MINE AND WELL EFFECTS EVALUATION

PROJECT RULISON

Open-file Report USBM 1002

March 1970

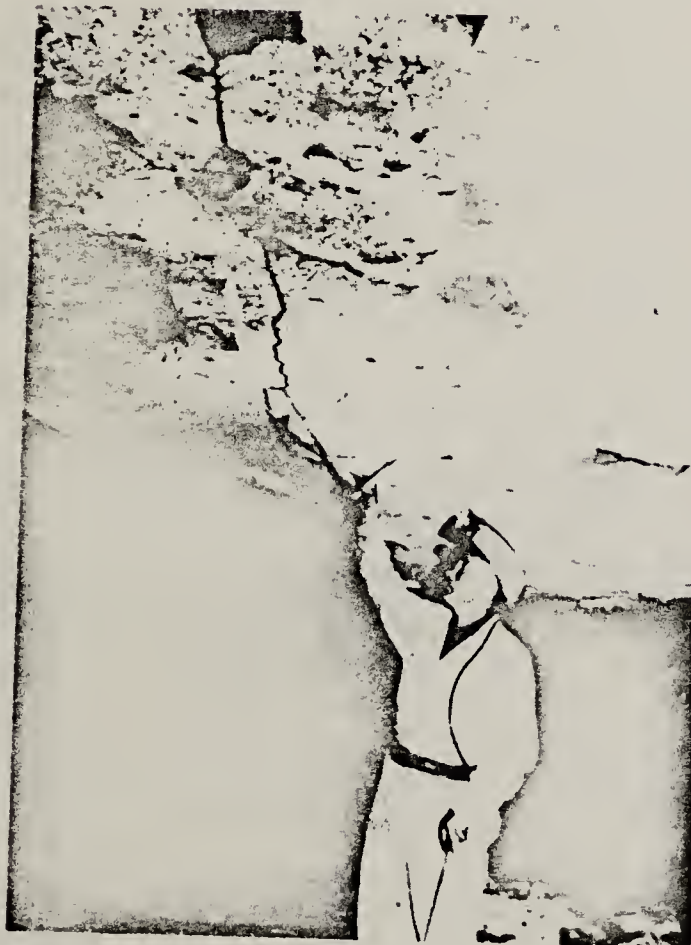
Fig. 4 - New 1/4-in by 150-ft crack
in caprock along No. 2 SW
entry at 1st crosscut.

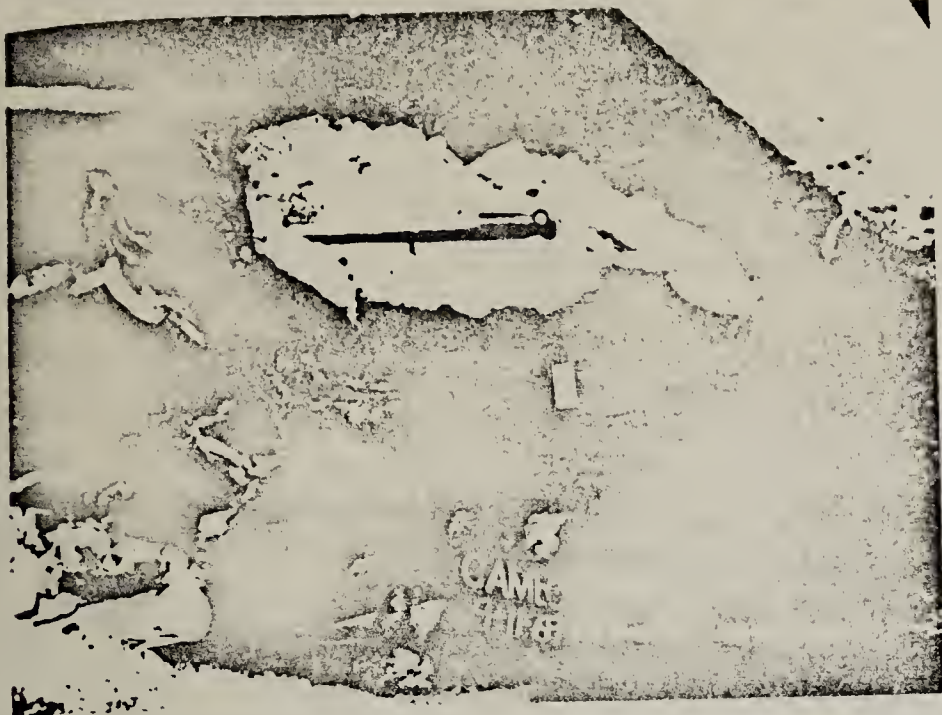
Most of the structural damage disclosed by the postshot inspection and attributed to the Rulison event, was confined to working areas under shallow cover, close to the outcrop--specifically the 1st Southwest section and the Nos. 1 and 2 Outside entries. In these areas of poor to bad roof, new cracks in the caprock were formed, and some of the old existing cracks were enlarged. (See figures 2 to 5.) A small roof fall also occurred along one entry, and the resulting separation of the roof strata adjacent to this fall placed excessive weight on several successive timber sets in the entry. (See figures 6 and 7.)

Fig. 6 - Strata separations in newly caved roof section outby face of No. 2 Outside entry.

Necessary repairs to this section of the mine, as determined by the consultant engaged at the request of the operator, involved the removal of 4 damaged timber sets, the cleanup of some 9 cubic yards of fallen rock, and the installation of 25 new timber sets along 150 feet of entry. The operator subsequently submitted a damage claim for cleaning up the fallen rock and systematically timbering 1,000 feet of entry with 200 timber sets plus 2 intersections with 6 sets. No reconciliation between the consultants' determination and the operator's claim had been made by the date of this report.

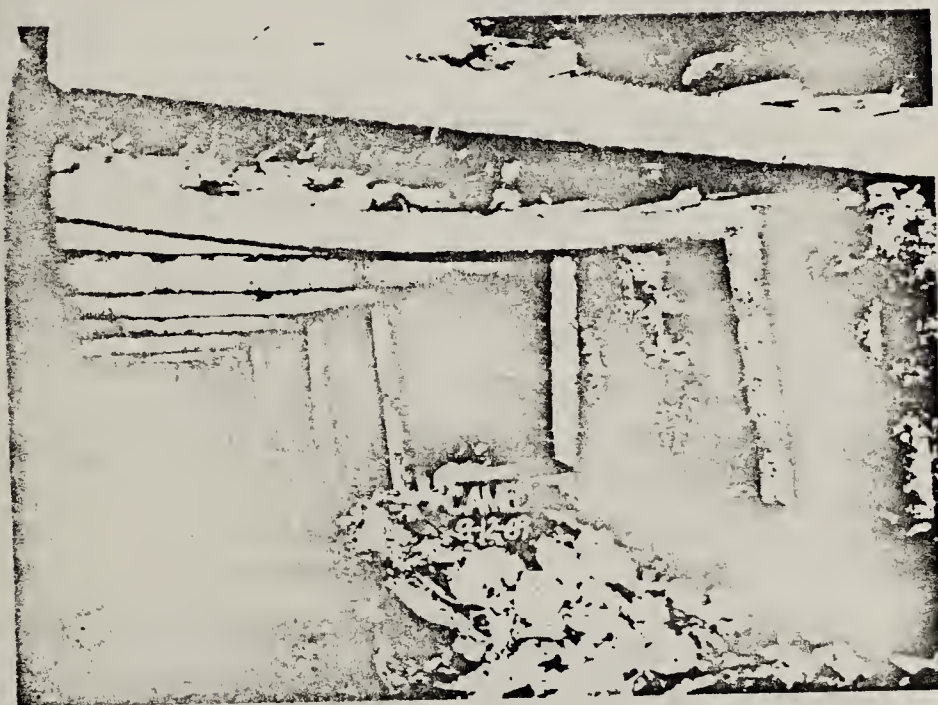
Fig. 7 - New roof fall and damaged timber supports outby face of No. 2 Outside entry.

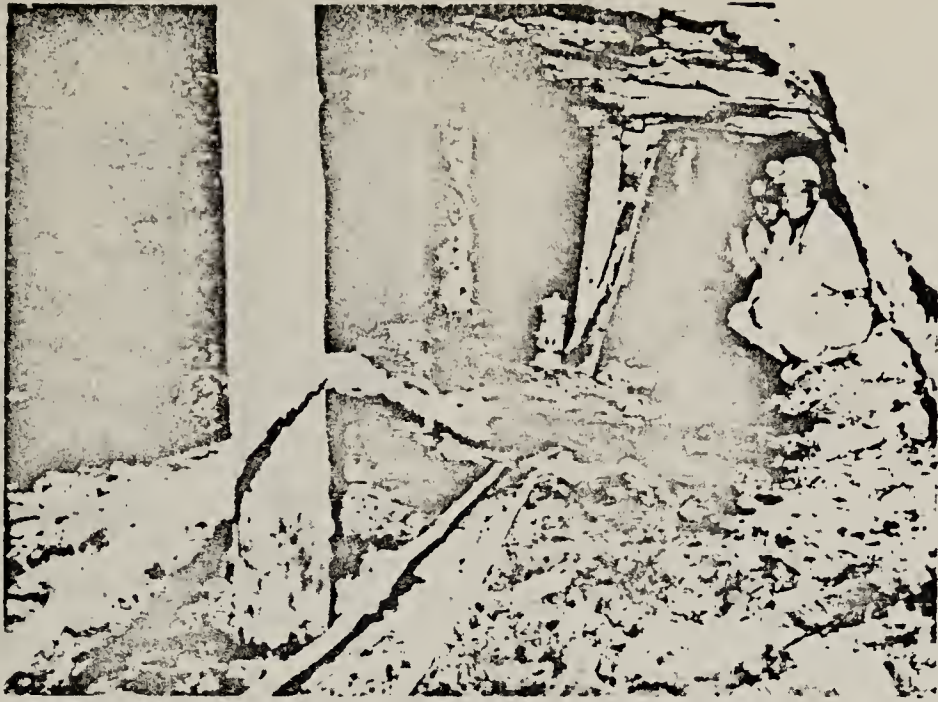
The special postshot inspection of this mine revealed that an aggregate of about 1/2 cubic yard of the shale caprock had recently fallen from the roof in four isolated sections of the workings. (See figures 8 to 11.) The most serious fall occurred midway along the inclined return airway where a thin slab, about 4 feet by 2 1/2 feet in area, had dropped onto the electrical power cables serving the mine. In dropping, this slab tore loose the power cables from their insulated hangers on two adjoining timber props. The cleanup of all the recently fallen rock and the rehangng of the power cables were estimated to require about 1/2 man-shift.

Fig. 8 - Thin slab of caprock down on power cables in return airway.

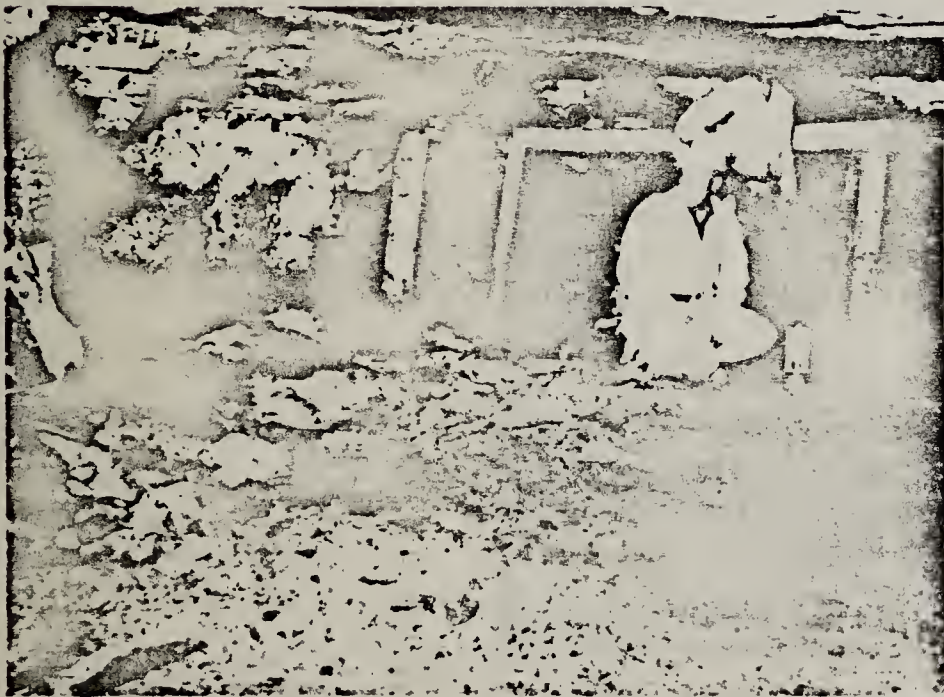
Fig. 9 - Caved caprock (darker material on top of old cave) in level entry east of shaft.

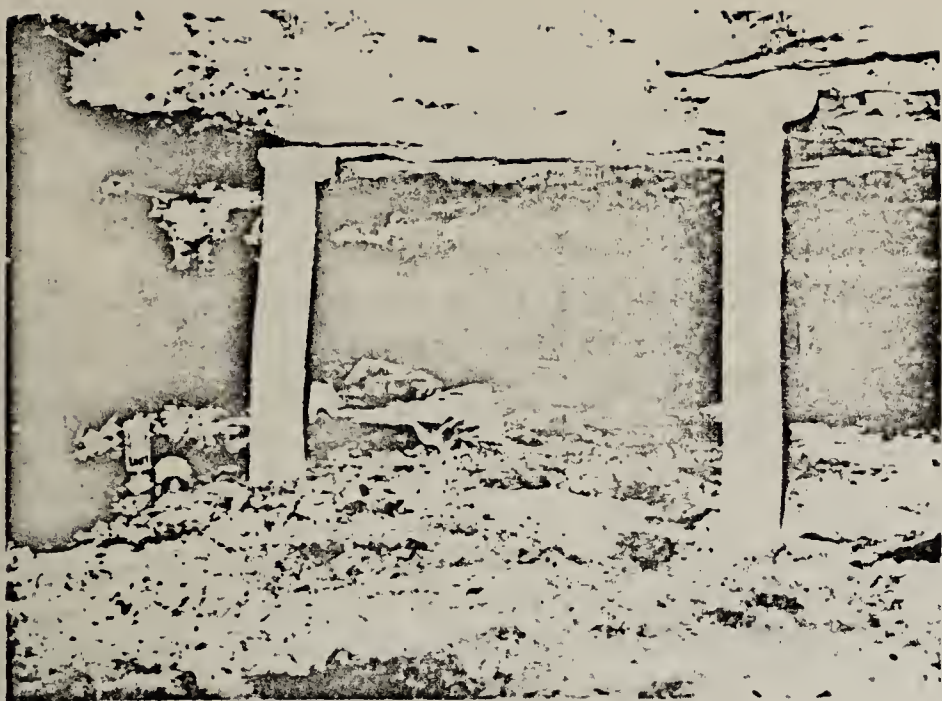
Fig. 10 - Caved caprock (by lamp and on shaker pan) in level entry east of shaft.

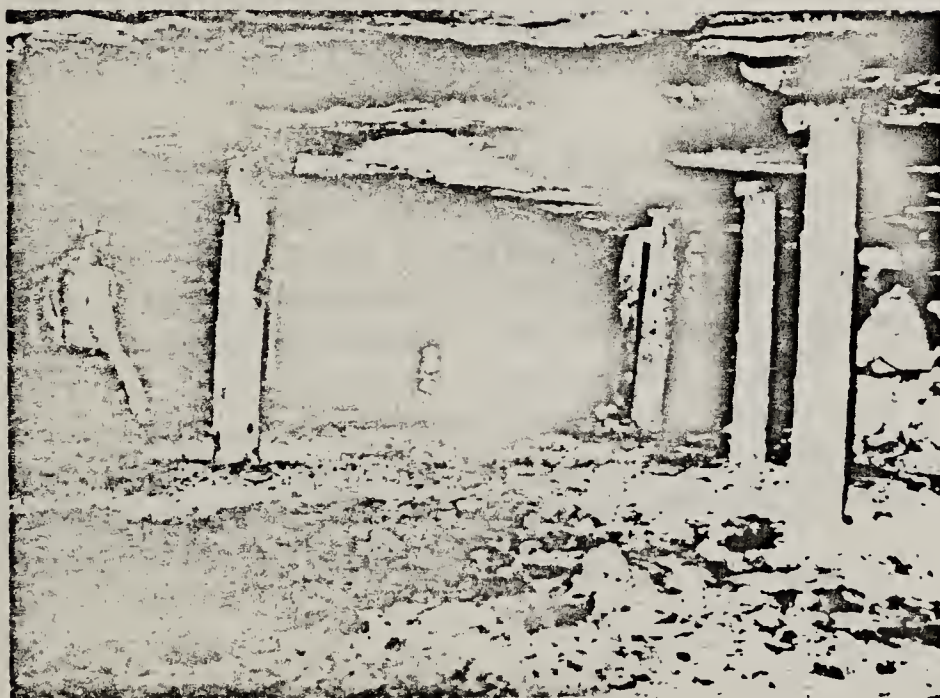
Fig. 11 - Caved caprock (darker material in foreground and below lamp) in old room from level entry east of shaft.

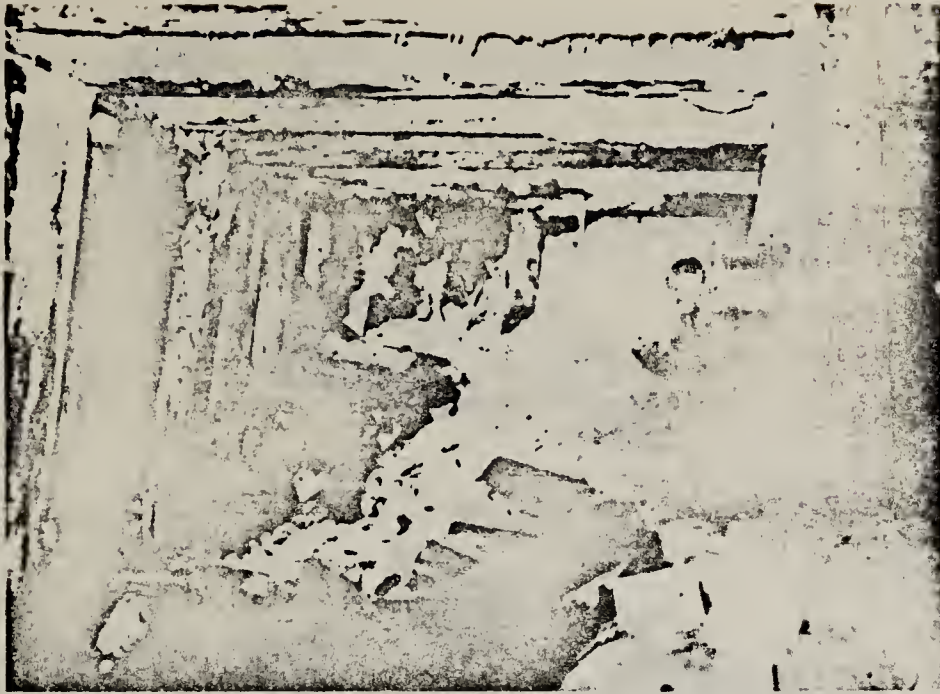
A major cave-in of about 130 cubic yards of rock and timber at 4,200 feet from the east portal, plus minor rock and timber falls at four other locations, was reported to have occurred sometime between September 9th and 15th. (See figures 12 to 14.) Investigations indicated that the major cave-in could have coincided with the Rulison event, but that the minor rock and timber falls may not have. No ground motion was felt in the immediate area, and such motion as could be projected for the area probably was too low to have caused the damage. Any consideration of the past history of the tunnel and its present physical condition leaves little doubt that the cave-in would have occurred sooner or later, irregardless of the Rulison event.

Fig. 12 - West end of major cave-in at 4200 ft.

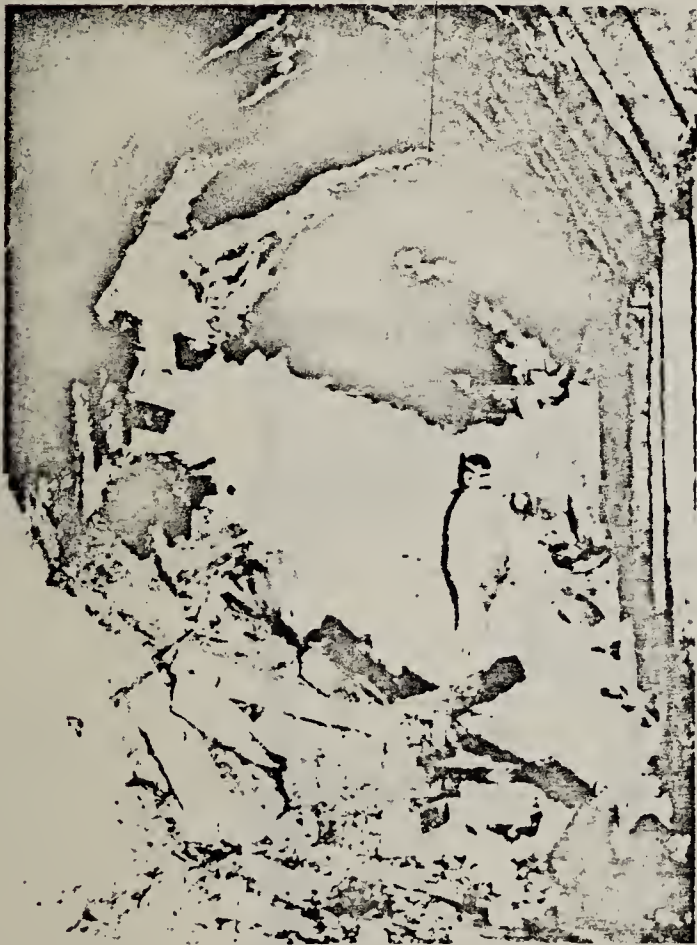
Fig. 13 - East end of major cave-in at 4200 ft.

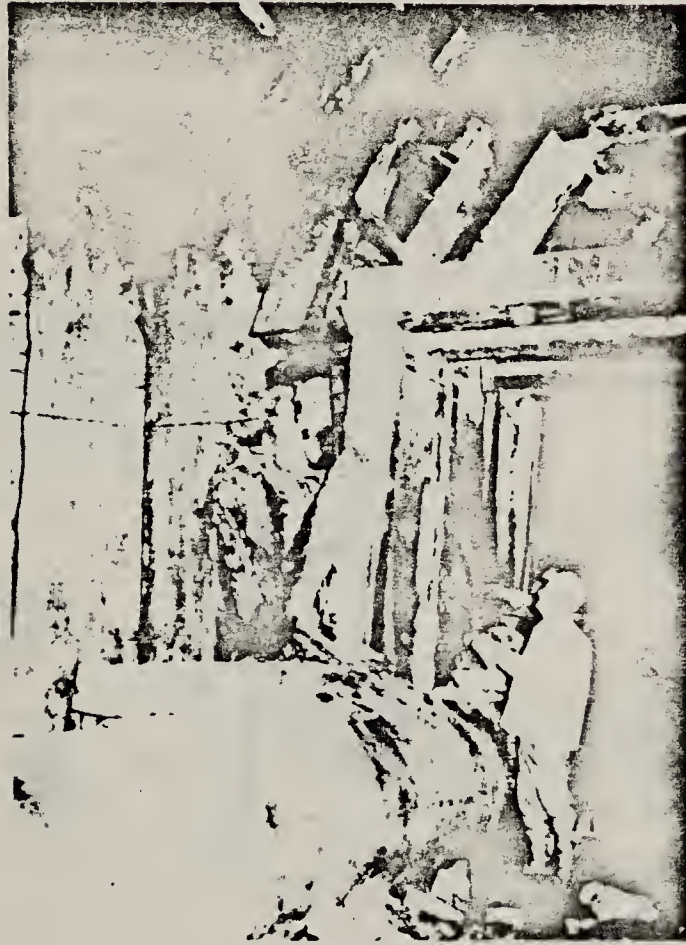
Fig. 14 - Disintegrated wall plate, toppled post, and sagged arch segment of old tunnel set at 4055 ft.

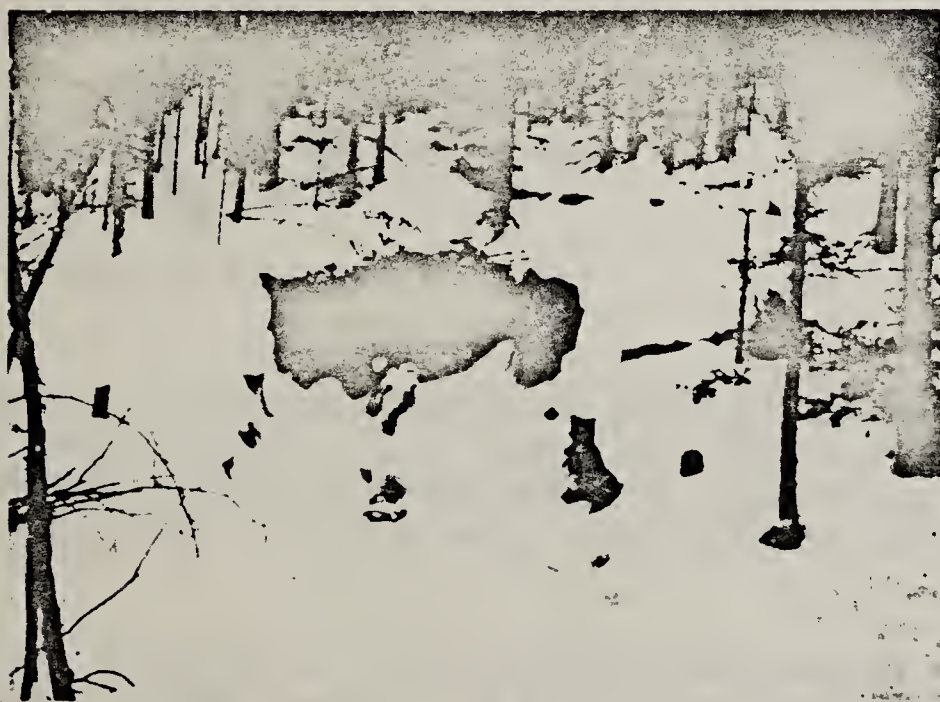
Carter mine Damages to the Carter and two other contiguous gold mines, consisting of caved adit portals in alluvium and caved drifts below old shrinkage stopes, also were reported as resulting from the Rulison event. (See figures 15 and 16.) An inspection revealed nothing conclusive that would tie this damage to Rulison. About all that could be determined was that it probably was of recent origin. The sections of the mines found damaged were those most susceptible to natural cave-ins. Considering the age of the workings, the conditions of the old timbers, and the altered nature of the Precambrian granite and schist wall rock, such cave-ins would be expected to occur periodically at any time. It was concluded that the damages reported were of natural origin and not related to the Rulison event.

Fig. 16 - Caved portal of No. 3 level of Golden
Islet mine.

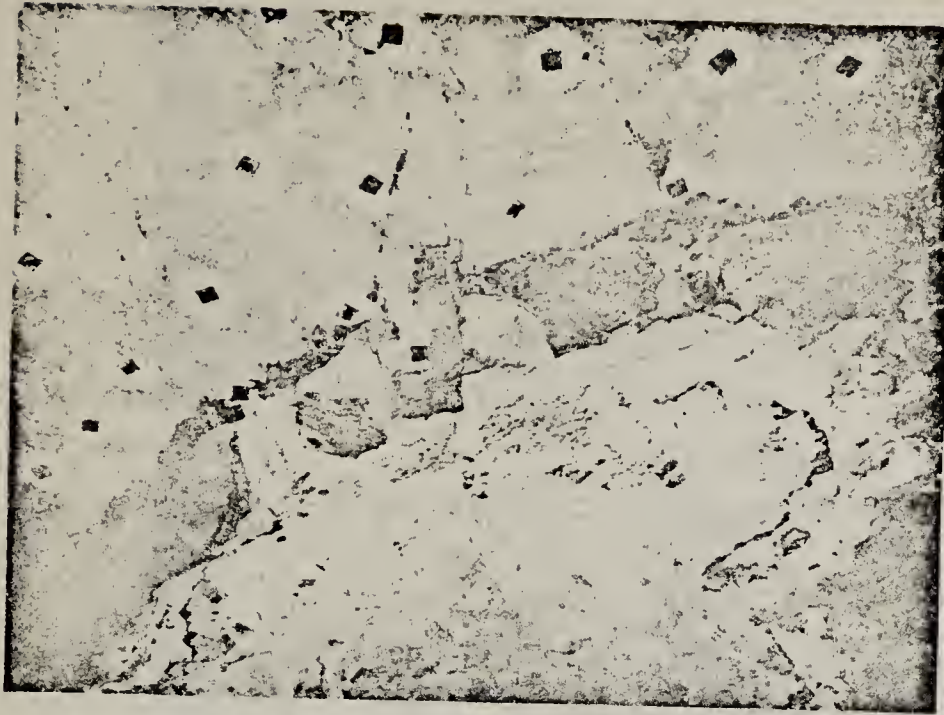
Loose rock hanging from roof bolts at edge of major roof fall area

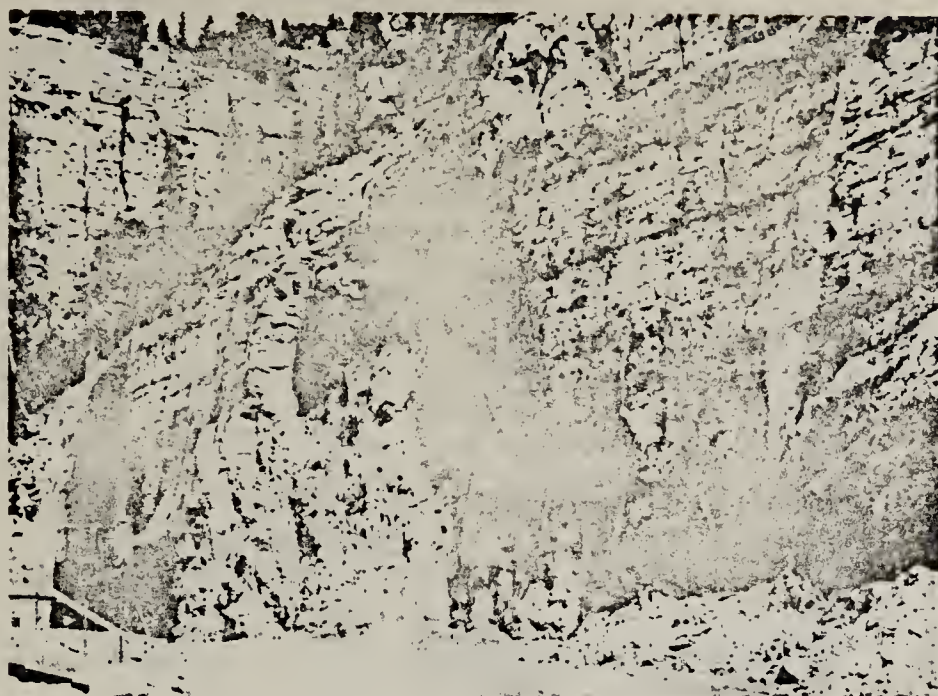
Caved section of vertical cut along mine yard

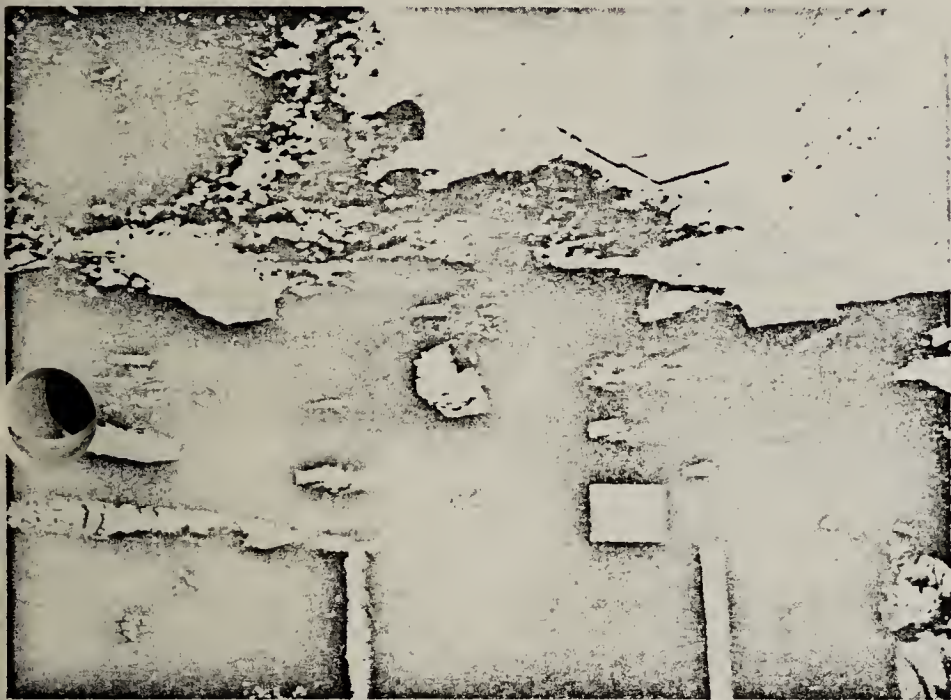
Caved cap rock around roof
bolts in 2nd East section

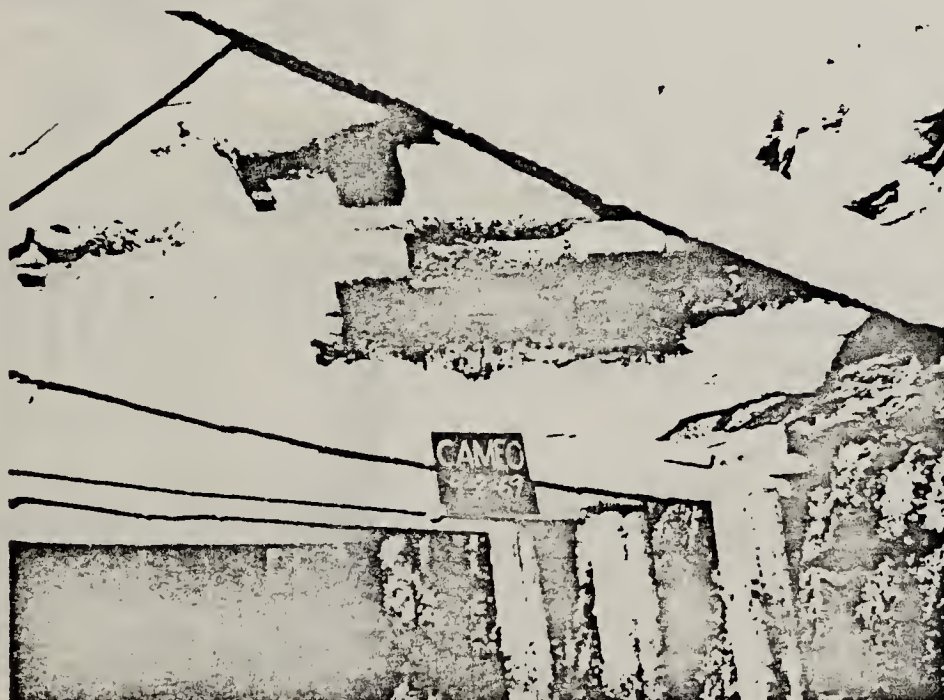
Cap rock and top coal
separation along No. 1
Southwest entry

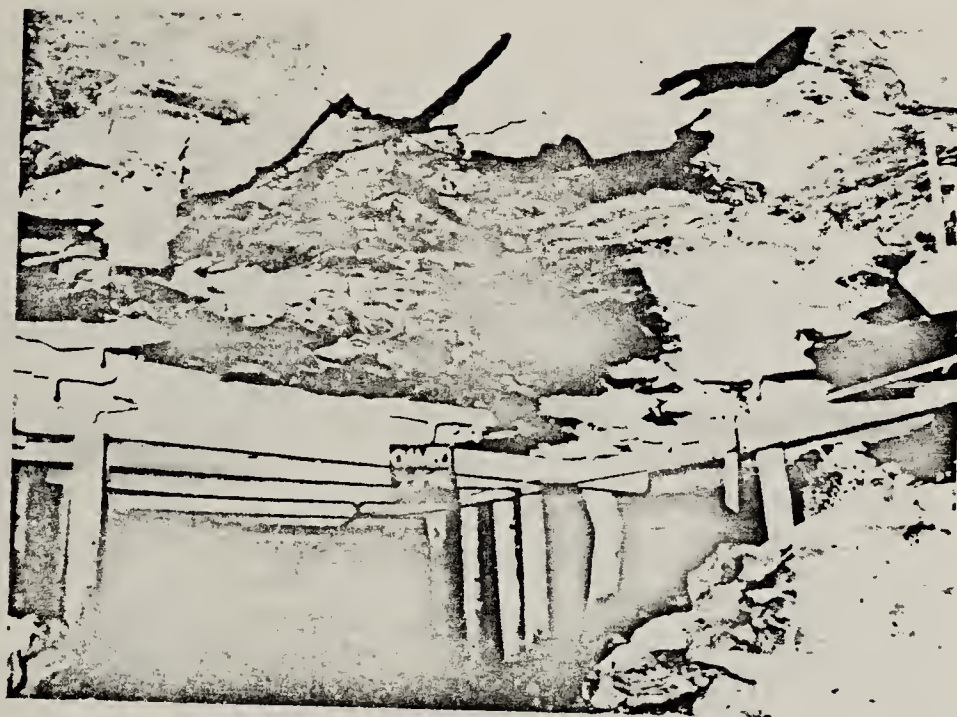
Caved roof of 3rd
West haulage entry

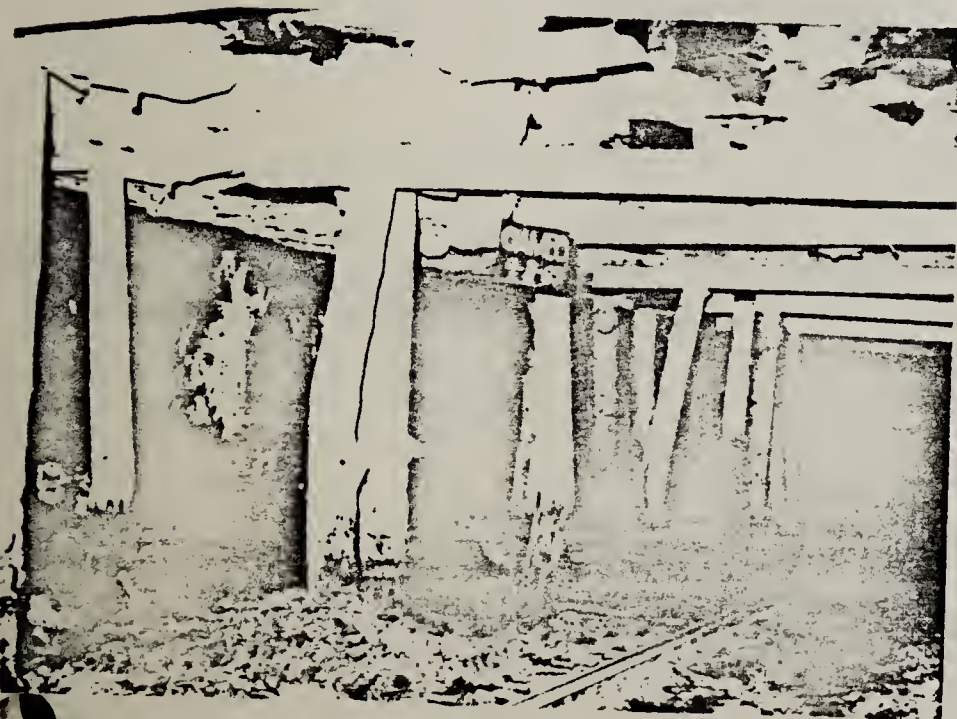
Timbers buckled from roof
sag and floor heave in 3rd
West haulage entry

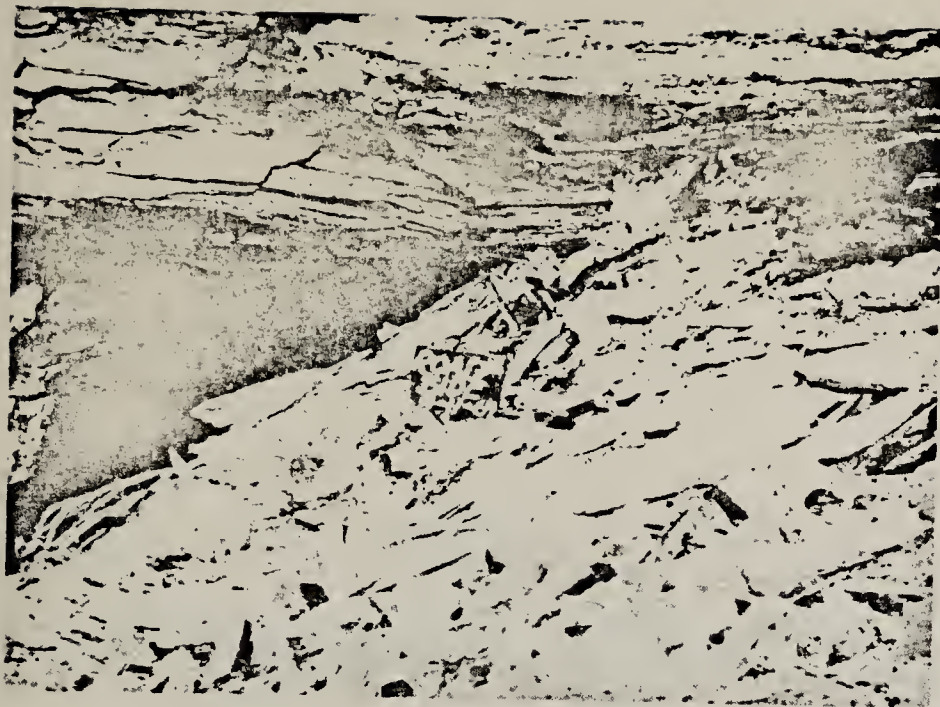
Recently caved material in air intake

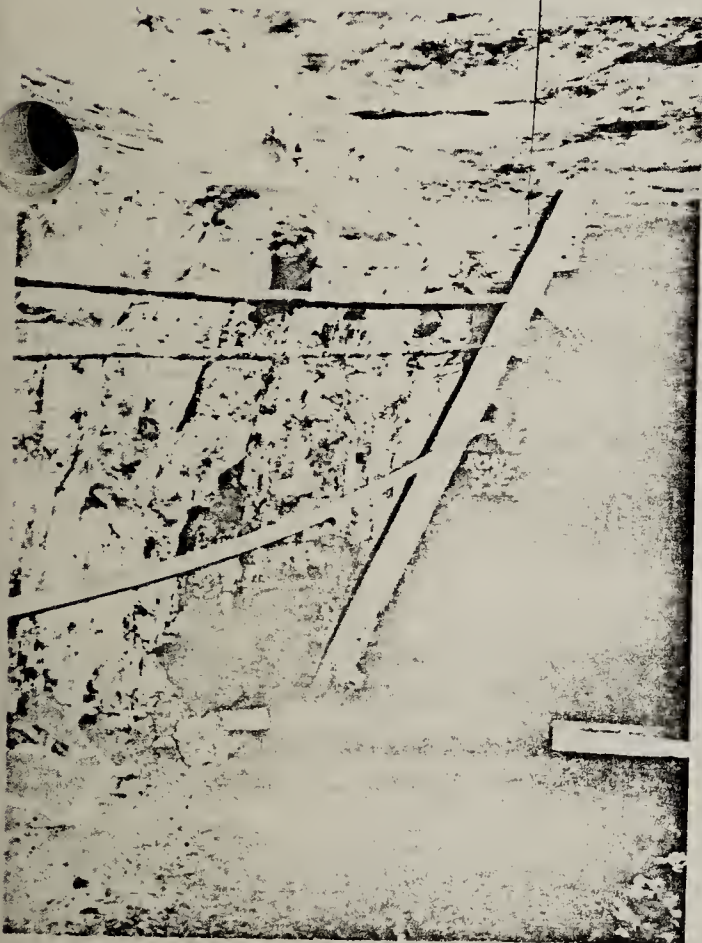
Toppled post and fallen cap piece in main haulage entry

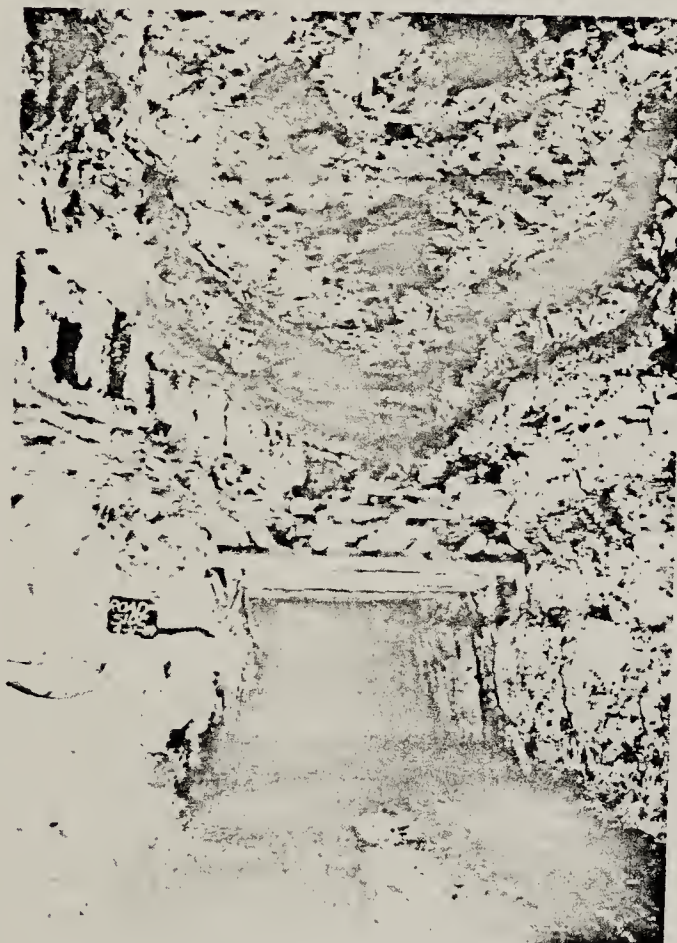
Caved section of main haulage entry

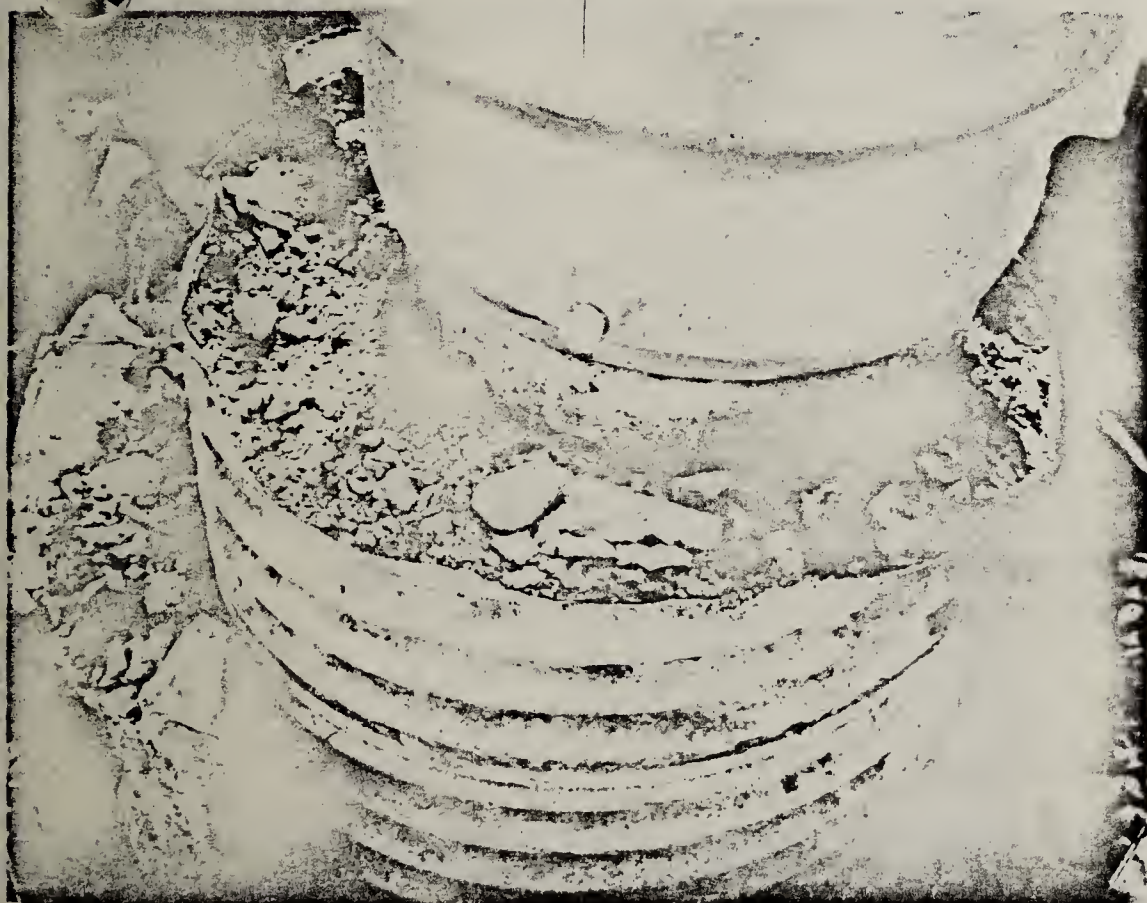
Photo 4 - Postshot

No surface damage was sustained by any of the gas wells, the gas pipeline, or by the emplacement well R-E or test well R-EX. No subsurface damage was evident at the field wells. Appraisal of subsurface damage to R-E and R-EX must await re-entry operations, although reservoir pressure is being transferred to the surface through the 10 3/4-inch casing in R-E. The only evidence of movement that resulted from ground motion was the space observed between the 10 3/4-inch casing and the earth fill in the R-E conductor pipe (Photo 4-Appendix).
